WOOD DESTROYING PESTS AND ORGANISMS INSPECTION REPORT

BUILDING NO. 2079	STREET, CITY, STATE, ZIP Olympic Blvd, Walnut Creek CA 94595	Date of Inspection 4/29/2021	No. of Pages 14
----------------------	---	---------------------------------	--------------------

General Description: Church building	Inspection Tag Posted: Subarea
	Other Tags Posted: No

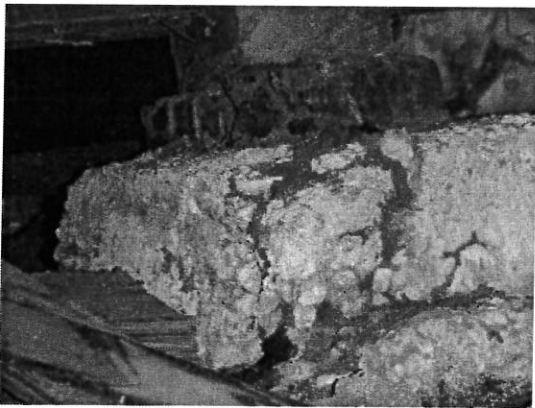
ITEM 1 There was evidence of termites noted in the structure.

RECOMMENDATION Perform a treatment as needed for the control of subterranean termites using TERMIDOR SC as per label requirements. Any holes that are drilled through concrete slabs and porches will be filled with cement mortar upon completion of treatment. Cosmetic damage will occur to surfaces that consist of concrete, tile and brick. All trenching will be back filled upon completion of treatment also. Any areas where there is carpet that has to be pulled back would be re-applied. However, we would not stretch same. Some cosmetic damage may occur to any floor surfaces that consist of linoleum. Our cost does not include any replacement of any vinyl. Care will be taken when drilling through slab areas to avoid any electrical and/or plumbing pipes. However, should any unavoidable damage occur to same it would be owners responsibility to have a tradesman specialized in that field to make necessary corrections and/or repairs as required. Termite tubes will be brush down.

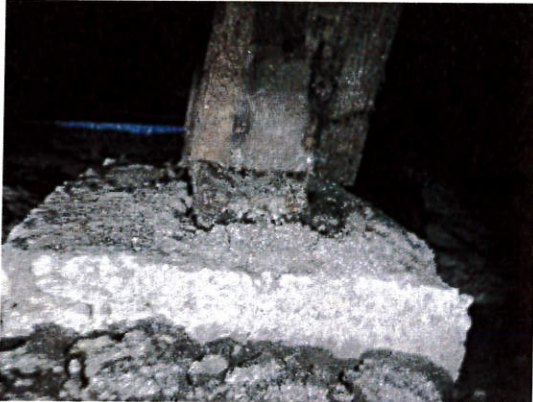
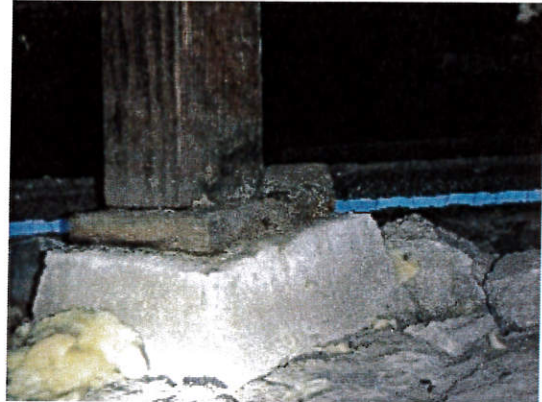
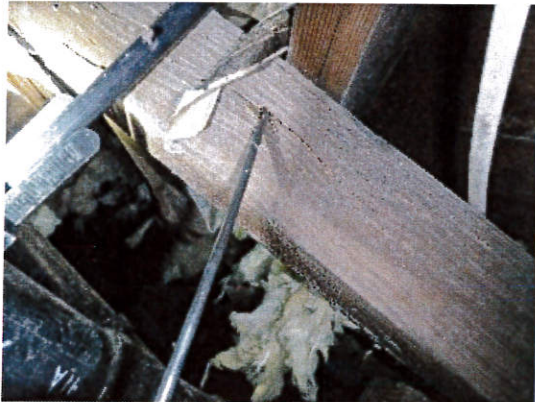
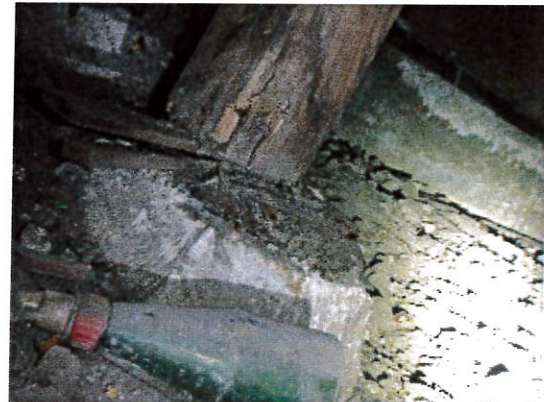
ITEM 2 Subterranean termites and fungus have damaged framing in the sub area.

RECOMMENDATION Remove the damaged wood as needed for further inspection. If no further damage is exposed, re support/replace with new material.

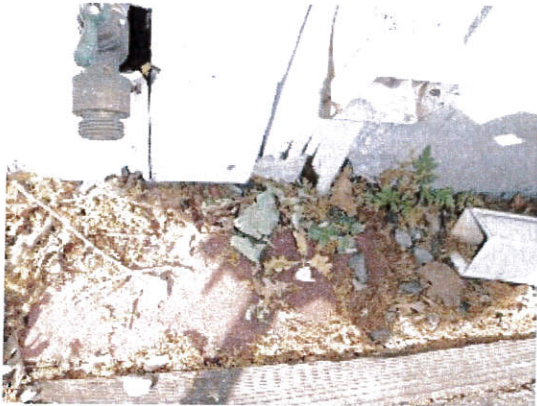
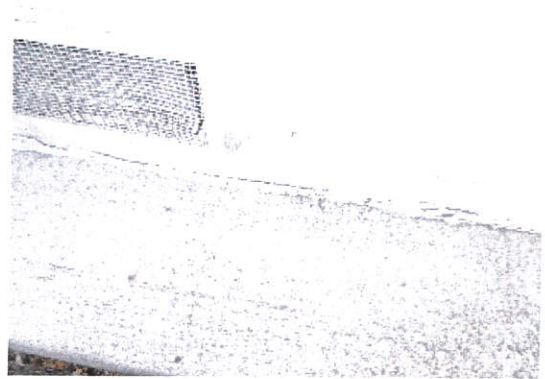
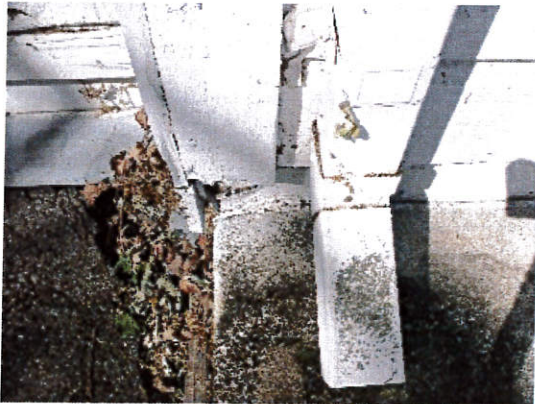
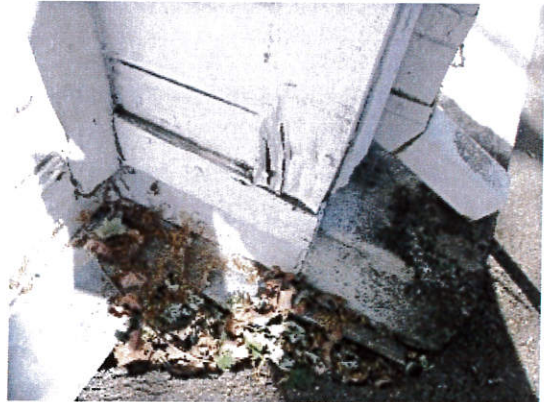
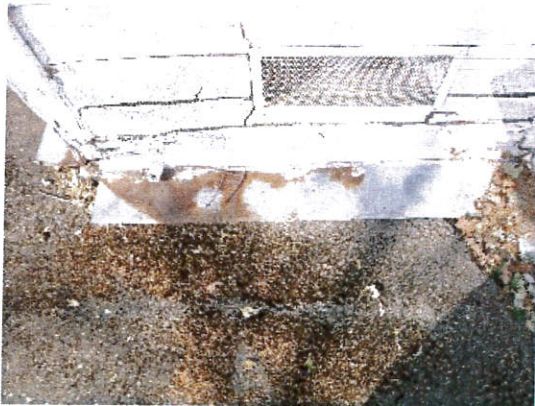
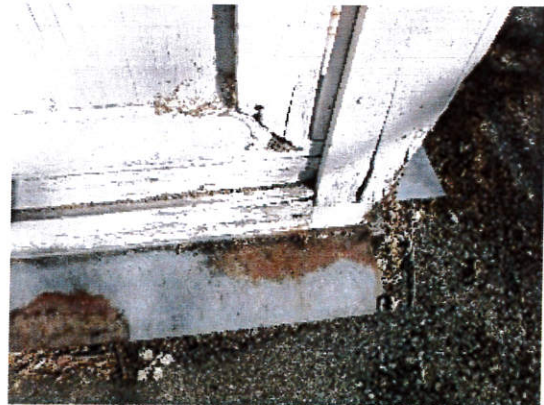
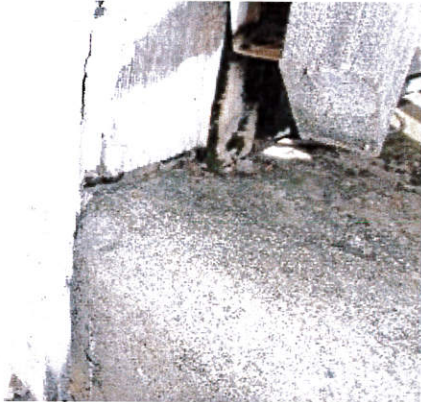
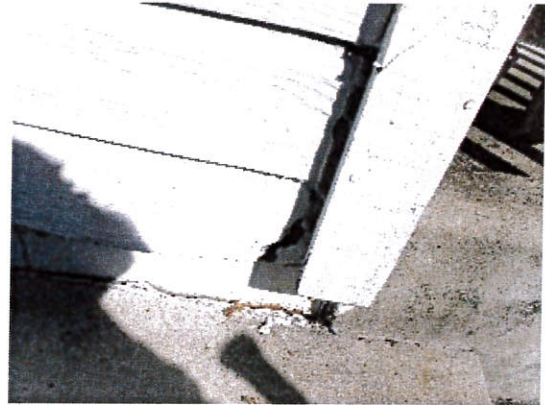
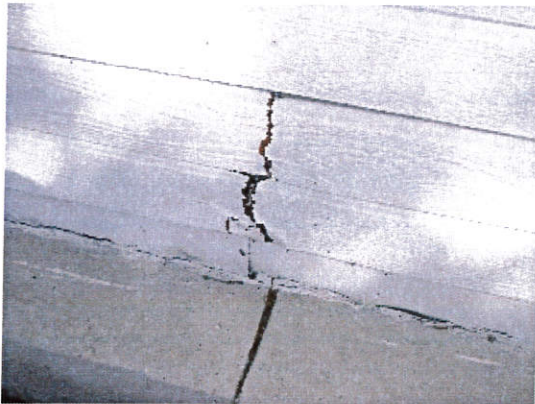
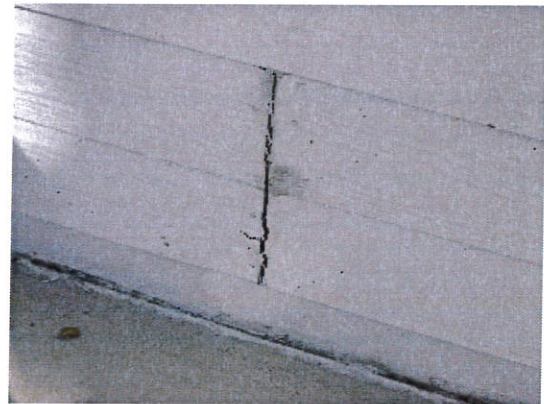
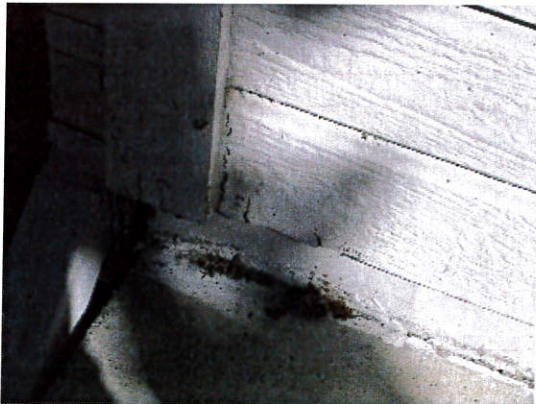
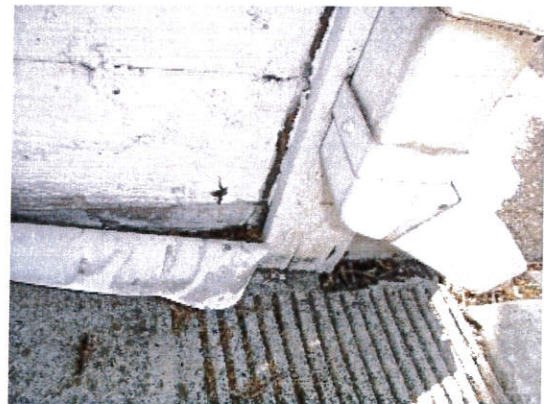
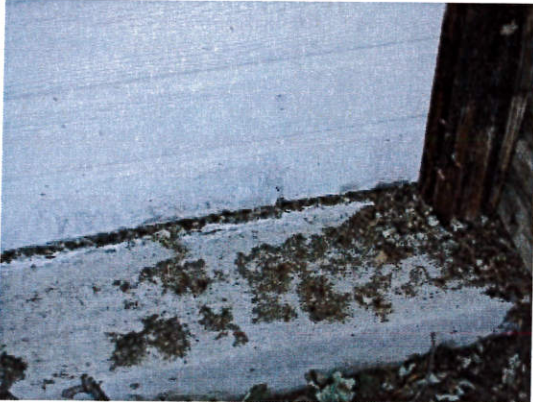
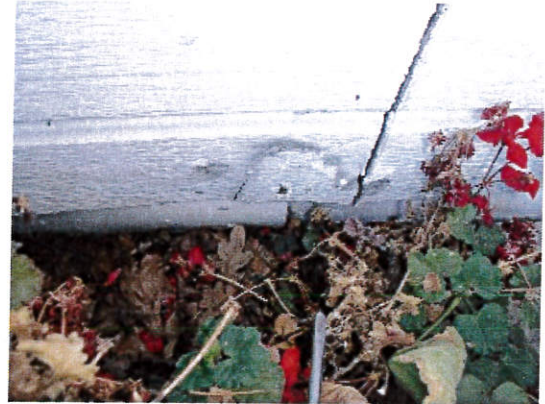
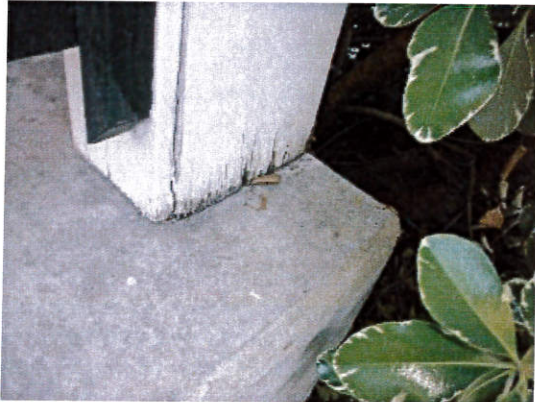
ITEM 3 Fungus damage was noted to the exterior siding and/or trim work at the approximate areas indicated on the diagram.

RECOMMENDATION Remove all damaged siding and/or trim as necessary and replace with new wood . Siding may have to be spliced. All new wood will be prime painted only and will not match existing color. Siding may not match in existing milling. All joints and seams that are repaired will be caulked and sealed on a one time basis only. Owners or interested parties are strongly advised that these areas are to be kept well caulked and/or sealed in the future. Any minor damage in these areas during the course of repairs to framing will be treated with a Tim-bor wood preservative during the process of work. Care will be taken not to disturb any interior finished wall surfaces, any damage occurring to these areas would be repaired left ready for others to finish paint same. IF DAMAGE IS FOUND TO BE MORE EXTENSIVE INTO FRAMING A SUPPLEMENTAL REPORT WILL BE ISSUED WITH COST FOR WORK.

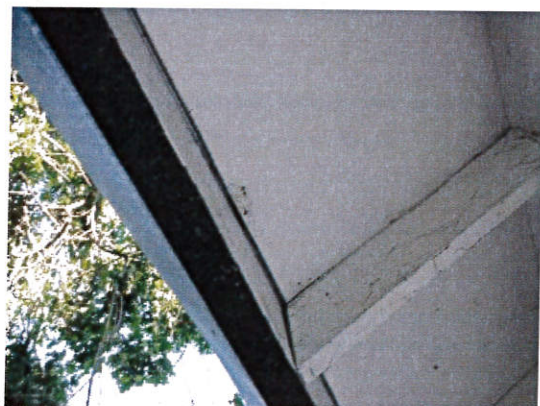
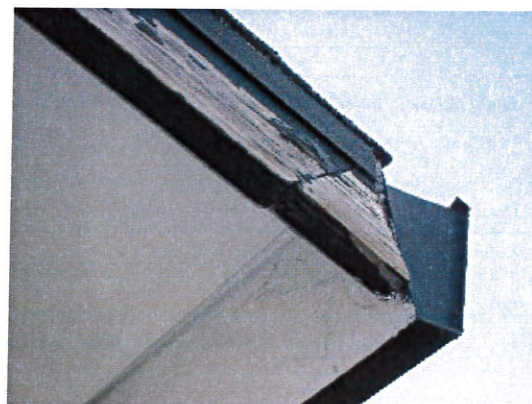
ITEM 4 There was damage noted to the roof line wood members at the approximate areas indicated on the diagram.

RECOMMENDATION Cut out and repair all damaged roof line wood members as required. New wood members will be prime painted, prime paint will not match in color. Milling of wood may not match. (IF ROOFING CAN BE REINSTALLED WE WILL MAKE NEEDED REPAIR)

IF ROOFING IS DAMAGED DURING THE COURSE OF REPAIRS. IT WILL BE OWNERS RESPONSIBILITY TO CONTACT A LICENSED ROOFING CONTRACTOR AFTER WOOD REPAIRS ARE DONE TO MAKE NECESSARY REPAIRS TO ROOF COVERING AS NEEDED.

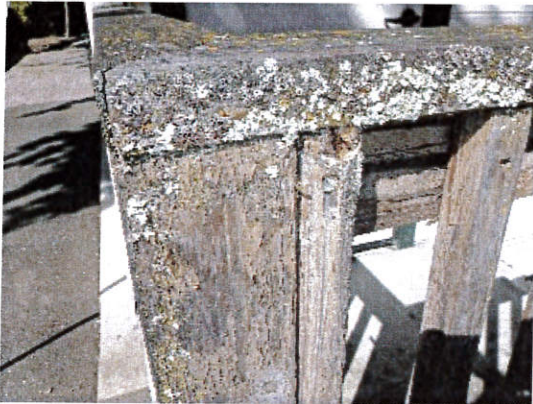
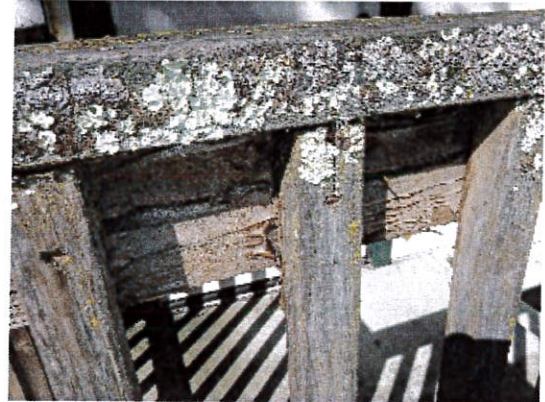
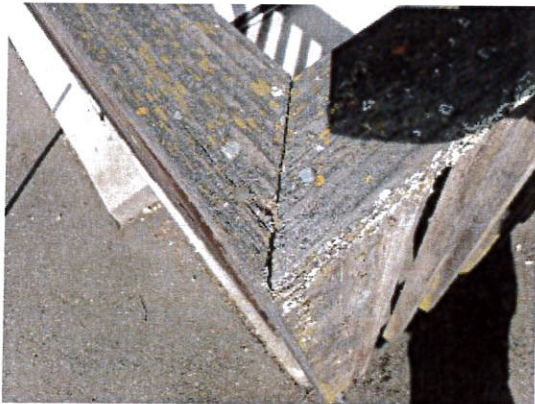
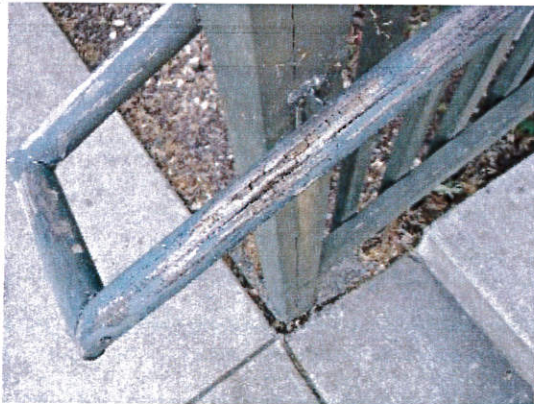
ITEM 5 Fungus damage was noted to the hand rail system.

RECOMMENDATION Perform spot repairs as needed, which will include the removal of the damage wood, replacement of new wood and painting with one coat of white primer. NOTE OWNERS OR INTERESTED PARTIES ARE ADVISED THAT OTHER HAND RAILS ARE WEATHERED AND WE STRONGLY ADVISE THAT OWNERS OR INTERESTED PARTIES KEEP ALL EXTERIOR HAND RAIL SURFACES WELL SANDED, PAINTED AND/OR SEALED AND REPLACED AS WHEN NEEDED IN THE FUTURE.

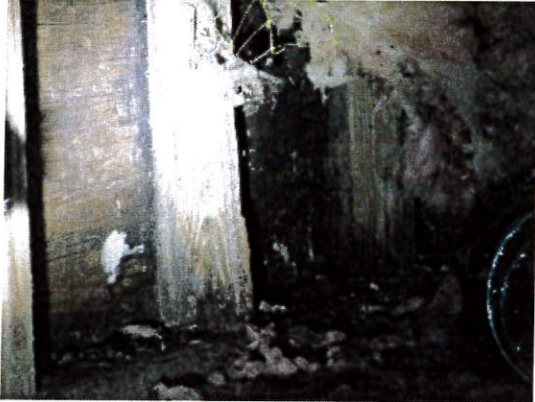
ITEM 6 Fungus has damaged the lower base framing at the area indicated on the diagram.

RECOMMENDATION Cut back the concrete step to expose the trapped siding. Remove the siding and damaged framing. Replace with new material. Install new flashing and repair the concrete as found necessary. Repair the siding around the step as found necessary.

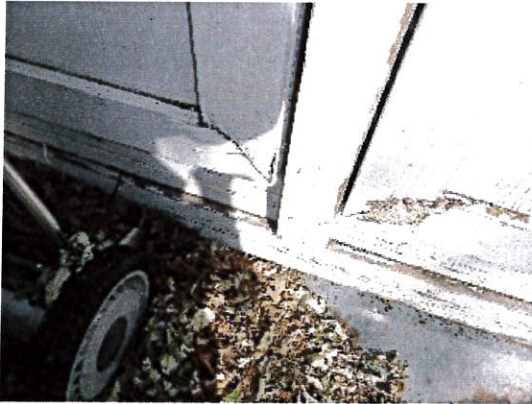
ITEM 7 Fungus has damaged these utility doors.

RECOMMENDATION Install a new utility doors. Prime paint only.

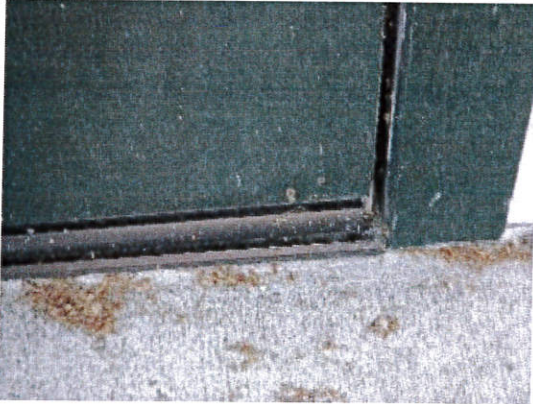
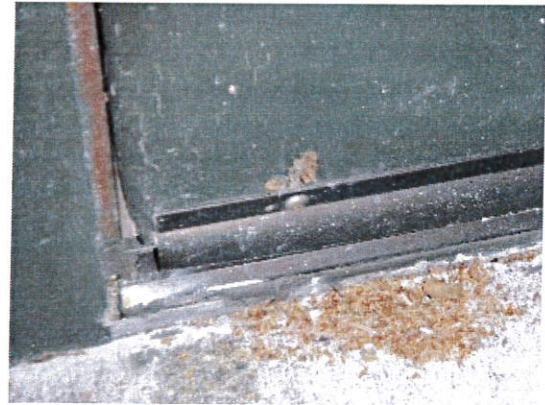
ITEM 8 Fungus has damaged these side doors.

RECOMMENDATION Install new exterior grade pre hung doors. Prime paint only.

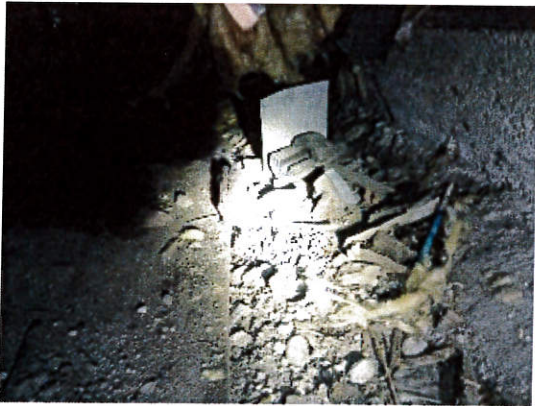
ITEM 9 Fungus infected cellulose debris was noted to be scattered on the substructure soil.

RECOMMENDATION Remove and dispose of all cellulose debris of a size large enough to be raked.
